RCA WO-33A Three-Inch Oscilloscope Rejuvenation

By Chris Prioli, AD2CS

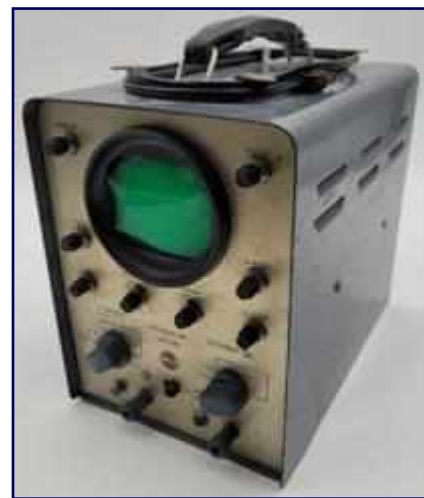
Figure 1 : RCA WO-33A Oscilloscope (with graticule)

Not too long ago, I picked up a well-used three-inch oscilloscope, an **RCA WO-33A unit (Figure 1)**, with the expressed intention of converting this 'scope into another piece of test equipment, namely a graphic semiconductor curve tracer. The main working parts of the 'scope would remain untouched, but an additional small power supply and a circuit board would be added in to provide the new functions that I wanted. The oscilloscope had its rubber bezel, but it did not have a graticule. This did not make any difference, because the graticule is not specifically needed for the curve tracer to operate acceptably. Down the road, I may make a new graticule out of some colored acetate sheeting onto which I can imprint a grid and scale, but that is another project.

The 'scope had been, as already mentioned, very well used, and its overall condition reflected that fact. The non-polarized two-wire power cord was in bad shape, with cracks and splits in several points along its length. The faceplate had been splattered with light blue paint droplets, and the vertical input BNC jack on the front panel was bent and badly corroded, making it unusable as an input jack.

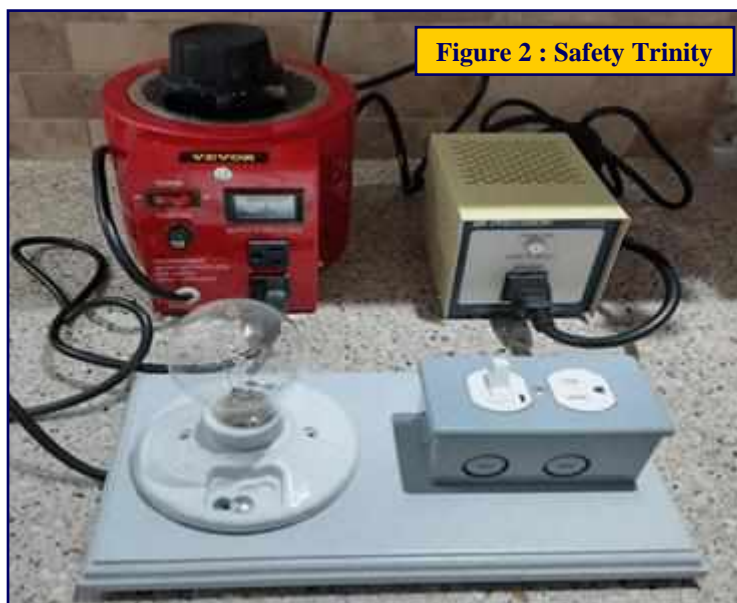
Figure 2 : Safety Trinity

All of these were minor issues in the overall scheme of things. Far more important to me was the electrical condition of the unit. I removed the 'scope from its cabinet and I hooked it up to what I call my "safety trinity" (Figure 2) - my dim bulb current limiter, my Variac™, and my isolation transformer to see what it would do. When I powered it on, the dim bulb went to full brightness and just stayed there, never dimming as it should have done if the 'scope were intact electrically. This indicated either a direct short circuit from line to neutral, or else some severe capacitor leakage.

Once all of the capacitors had been replaced and the new line cord and its associated safety capacitors were installed, I once again connected the ‘scope to the safety trinity and powered it up. This time, the bulb of the current limiter started out bright, and then rapidly faded to a more normal dim state. This was a good sign, showing that the current draw was at or near proper limits. I then took a reading of the actual current being drawn by the oscilloscope, and found it to be a very reasonable 438mA. Upon power-on, the initial current draw peaked at 1321mA, a not unexpected start-up surge. This data was important, because it enabled me to determine a proper fuse for installation as a protective device. In addition, it was right in line with the average power consumption of 50 watts that is stated in the assembly manual’s Electrical Specifications section, calculating out at about 51.465VA when the 438mA is multiplied by the measured 117.5VAC line voltage in my shop.

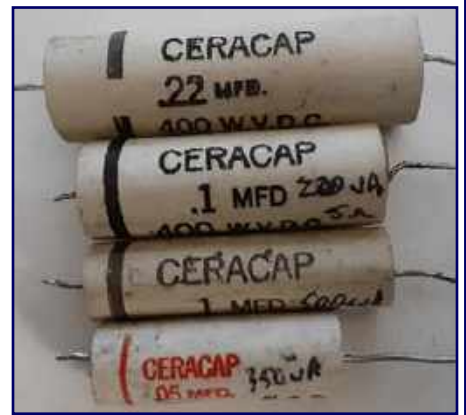
Figure 3 : CERACAP Examples

Anyway, the capacitors that I believe were all factory components were all of a type - ceramic tubes with wax filling, all marked as being CERACAP devices (**Figure 3**) from American Radionic Company, Incorporated. Some research showed that American Radionic is still around today, located now in Palm Coast, Florida, some sixty miles south of Jacksonville, where they relocated after leaving Danbury, Connecticut in the late 1980's. Their AmRad line of motor-run capacitors are considered to be world-class products. However, in the 1950's and 1960's, they were a major supplier of wax and paper capacitors to consumer TV and radio manufacturers.

As is evident from the data in *Table 1*, all of the capacitors believed to be originals had significant leakage and had considerably higher than acceptable ESR values. As such, it was best that these capacitors were all replaced. The aggregate leakage of these capacitors was a contributor to the excessive current drawn by the ‘scope on power-up.

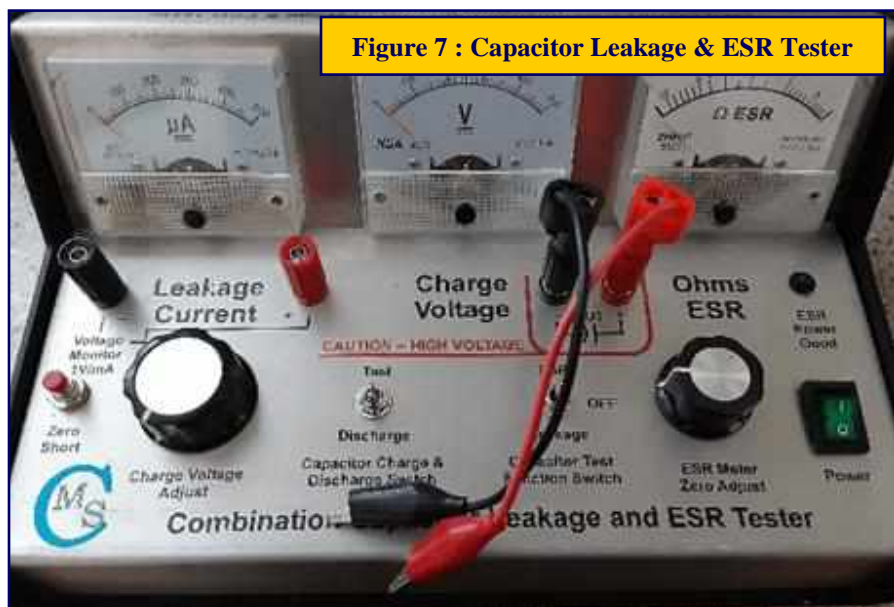
Figure 7 : Capacitor Leakage & ESR Tester

After replacement of the capacitors, I decided to investigate the exact condition of the capacitors that I had removed. I did this using a capacitor tester of my own design and build (**Figure 7**), which tests capacitors for leakage and for ESR. What I found, detailed in **Table 1**, is quite revealing.

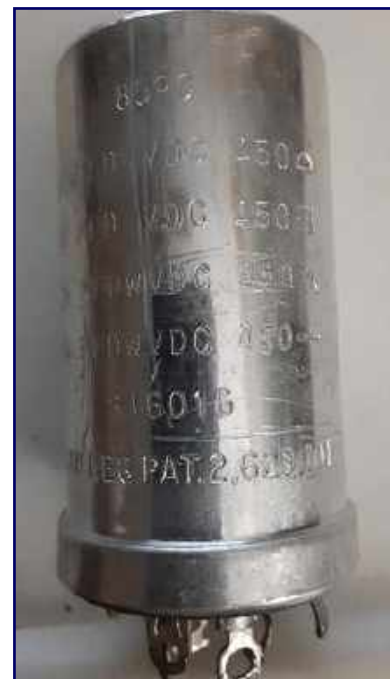
Figure 8 : Original C38 Capacitor

The WO-33A Oscilloscope also uses two can-type multi-section aluminum electrolytic capacitors, each of which is a 450-volt 40 μ F/20 μ F/20 μ F/10 μ F four-section device. The replacement devices are of the same capacities, but are rated at 475 volts instead of the original 450 volts. These capacitors are used at locations C38A-D and C39A-D. C38 is in the 6BR8A pentode/triode vacuum tube vertical input amplifier circuit, while C39 is used as the incoming power filtering capacitors immediately subsequent to rectification by the 6X4 dual-diode vacuum tube. The original capacitors in these locations were unmarked as to manufacturer or date, but they were marked with a patent number and a part number (*Figure 8*). A quick Google search on the patent number showed that the patent was a 1952 (23 December 1952) application, made by Jerome J Kurland and Joseph J Kurland. Some more research showed that these two gentlemen were the co-owners of a company called Illinois Condenser Company of Chicago, Illinois. From that information, one would have to conclude that these capacitors were manufactured by the Illinois Condenser Company.

As can be concluded from the values in the table above, the electrolytic capacitor sections all exhibited extremely high leakage. High leakage is quite typical of electrolytics, but generally not to the extent seen here. This leakage, taken together with the leakage of the film capacitors, was clearly enough to cause the excessive current draw seen in the initial power-up test.

The replacement devices are the product of CE Manufacturing of Tempe, Arizona. CE Manufacturing produces a fairly extensive product range of multi-section can-type electrolytic filter capacitors, intended primarily as replacements for guitar amplifiers and older radio receivers. I have used their capacitors in several refurbishing projects over the past few years, always with great success. They are drop-in replacements as far as size, pinout, and appearance are all concerned.

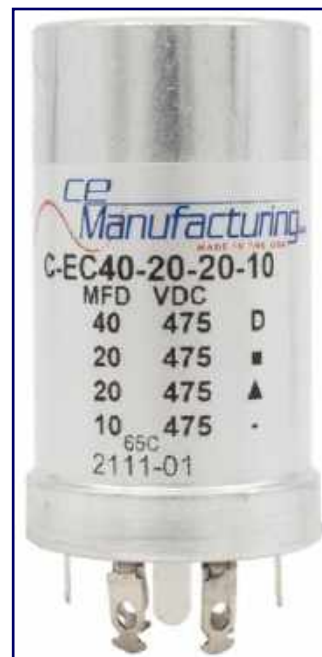
Figure 9 : Capacitor Label

On capacitors of this type, the individual sections are identified by a symbol (▲, ■, or ◐) adjacent to each terminal. In a four-section device, the fourth terminal is unmarked or marked with a line or dashes (--). In most cases, a legend is marked or labeled on the body of the capacitor (**Figure 9**), indicating which section carries which ratings, both as to capacity and as to voltage. The capacitor shell is the common negative side of the internal capacitors.

The “X1-440V/Y2-300V” designation indicates that this capacitor can be used in the X1 circuit configuration at voltages up to 400VAC, and in the Y2 circuit configuration at voltages up to 300VAC. The X1 configuration is that in which the capacitor is placed across the power line, from one lead to the other, while the Y2 configuration is that in which the capacitor is placed in the circuit from one line cord lead or the other to the chassis or ground. In this oscilloscope, the capacitors C36 and C37 are used in the Y2 placement.

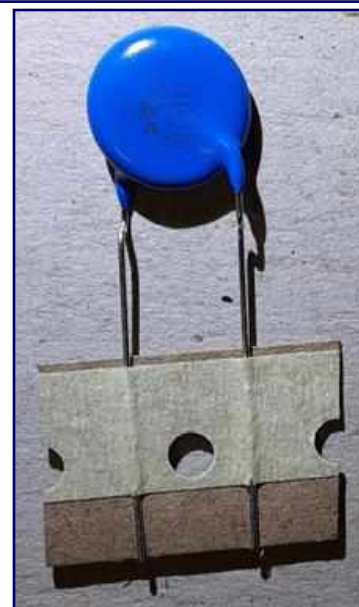
Figure 10 : 0.01 μ F Safety Capacitor

Continuing with the capacitor specifications shown for the safety capacitors, the “±20%” is the tolerance of the capacitor, or the variation from the nominal value within which the capacitor will fall. Thus, the 0.01 μ F capacitor will be found to be within the range of 0.008 μ F to 0.012 μ F. Finally, the “Y5V” is the designator for the dielectric used in construction of the capacitor. Disc capacitor dielectrics are assigned alphanumeric codes that describe the properties of that dielectric compound. Each of the three characters conveys a specific meaning. In this case, the “Y” indicates that the lowest temperature for which this capacitor is rated is -30°C (-22°F). The “5” indicates that the highest temperature for which this capacitor is rated is +85°C (+185°F). Finally, the “V” tells us that the amount of capacitance change over the temperature range is +22% to -82% of the nominal value. A table of the common dielectrics and their meanings can be found in the article Capacitor Markings and Identification, a part of my Basic Electronics Series, which can be found on my website at <https://www.ad2cs.com/electronics-articles-and-publications>. Please feel free to browse through the website and have a look at the many articles and publications found there.

The 'scope required replacement of its power cord because of the condition of the existing cord, as mentioned earlier. I replaced the cord with a two-prong polarized power cord, placing the LINE lead in series with the power switch, identified only as "POWER SWITCH" and ganged to the 75k Ω INTENSITY potentiometer R73. At that time, I also added the two 0.01 μ F capacitors from the power cord leads to the chassis. The capacitors I used are X1-440V/Y2-300V \pm 20% Y5V ceramic disc safety capacitors (**Figure 10**). Safety capacitors are specially designed so as to fail, when failure occurs, in the "open" state rather than failing "shorted". This is important in any capacitor placed across the power line or placed between the power line and chassis (or other) ground.

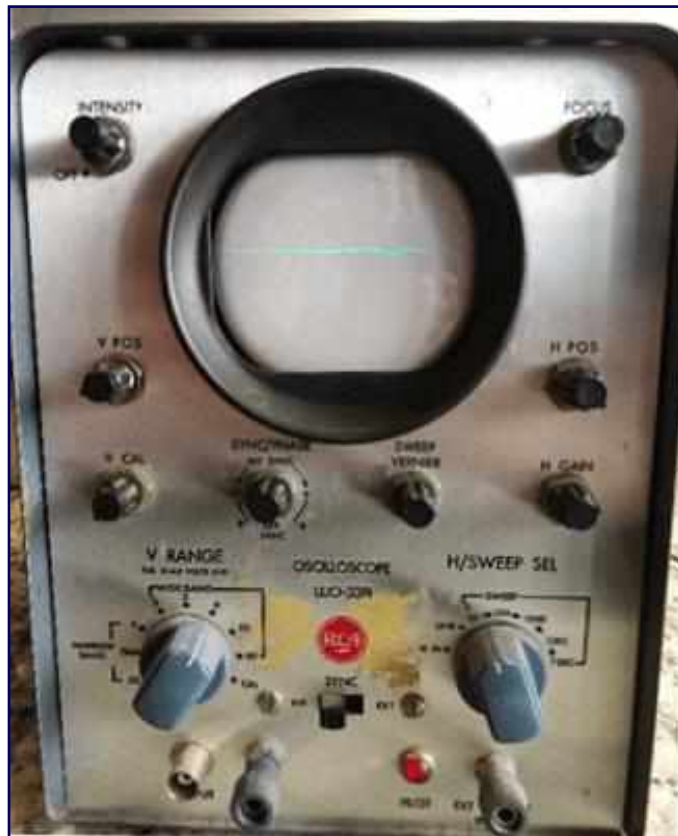
Figure 12 : Working Oscilloscope

At this point, the **RCA WO-33A Oscilloscope** is operating in accordance with its design standards (*Figure 12*), and is ready for its final conversion to its new purpose and life as a semiconductor device curve tracer. The next step is to design and construct both the power supply and the curve tracer interface board. Once they have been designed and bread-boarded, I will have the PCB's manufactured. After that, I can install them into the oscilloscope enclosure, mounting them to the chassis rails. I will write another article describing those processes as they progress to completion.

With the repairs and cleaning completed, it was time to pay some attention to the external appearance of the unit. This turned out to be a relatively minor issue, as the blue paint which had been splattered across the front panel, the upper surface, and the left side panel all came off with some acetone on a soft cloth. The remainder of the stains and debris on the enclosure all came off with some denatured alcohol and another soft cloth, using an old toothbrush to scrub the corners and crevices. A final wipe-down of the front panel with the denatured alcohol finished the clean-up of the unit, though I still need to find a way to safely remove some tape residue without damaging the RCA logo, as can be seen in the *Figure 12* photo.
